Report

Incident on **2 June 2010**

Bordeaux FIR, OLRAK Point

between the **A318** registered **F-GUGJ** operated by **Air France**
and the **PC 12** registered **EC-ISH**

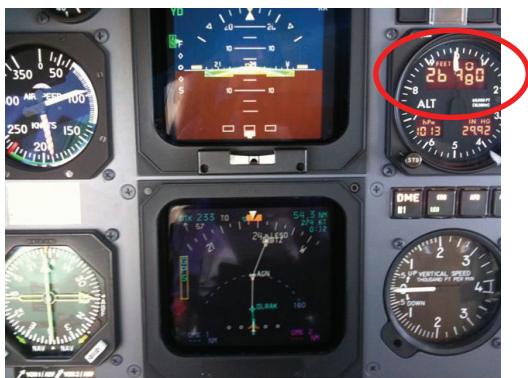
During the climb towards FL 270, they noticed that the differences in altitude and speed between the 2 barometric and speed units were increasing. Stable at FL 270, they saw on the first unit, on the pilot's side, FL 270 and an indicated speed of 90 kts and on unit 2, on the right side, FL 290 and an indicated speed of 160 kts. The crew tried to dispel this doubt with the GPS but the GPS altitude was between 27,000 feet and 29,000 feet and did not allow them to dispel the doubt (see note below).

Figure 2:
Left side barometric and speed unit

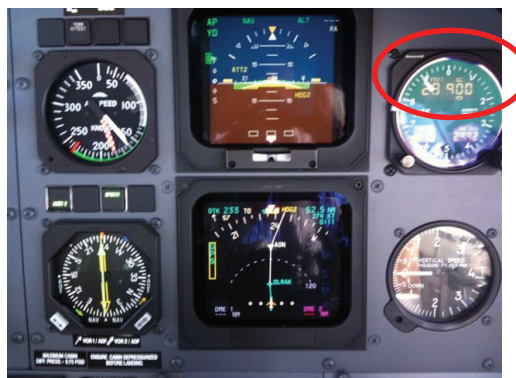
Figure 3:
Right side barometric and speed unit

Thus the speed displayed on the right side unit was consistent with the flight conditions at that moment.

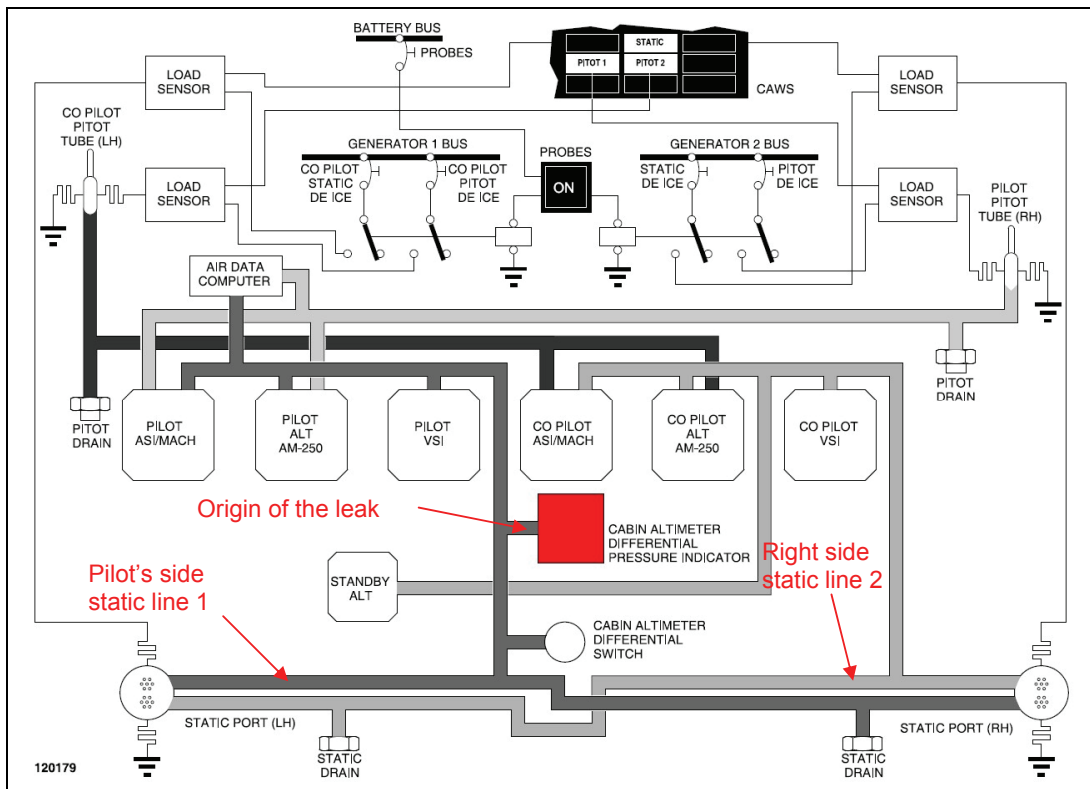
Figure 4: Synoptic of the speed installation on the PC-12

The airplane being pressurised, it possesses a cabin differential pressure indicator that uses the static pressure pneumatic line on the pilot's side to develop its indication (in red in figure 4).

The search for the failure on the airplane the day after the incident showed that the pilot's side static line (see figure 4) had a leak on a connector that joined this line and the cabin differential pressure indicator (parts referenced 3 and 4 on figure 5).

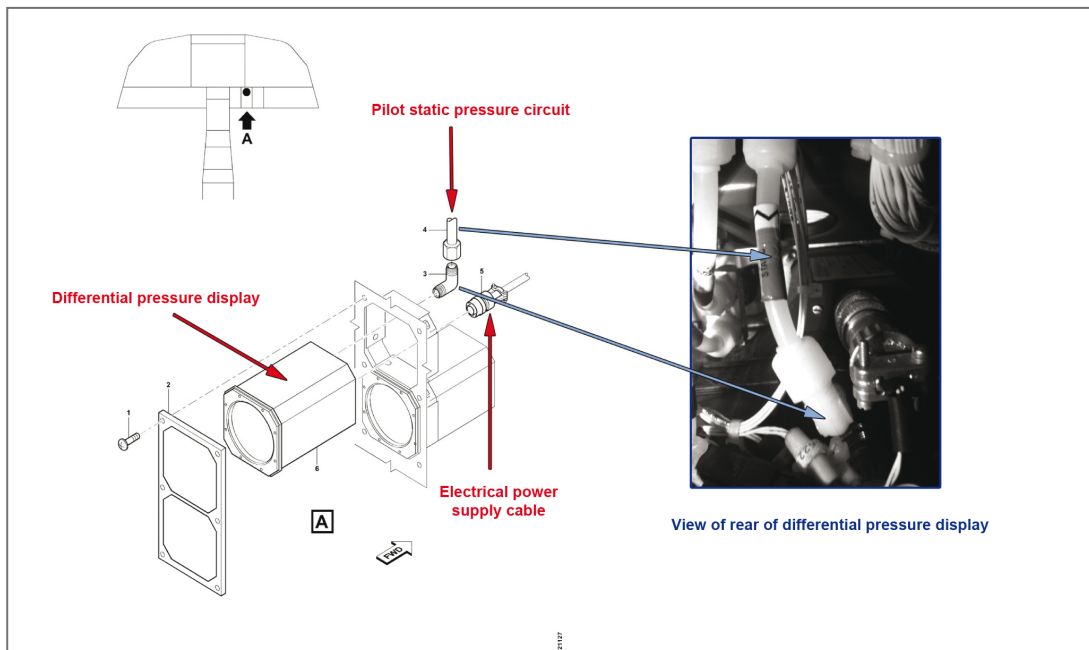
Thus, a part of the pressurised air in the cabin was able to penetrate the static pressure line and increase the value of this pressure. This increase in pressure was, at FL 290, equivalent to a value of 2,000 feet.

Due to this, as soon as the cabin was pressurised, the instruments on the pilot's side indicated an altitude and a speed that were lower than they were in reality.

Figure 5: Schema and photo of installation

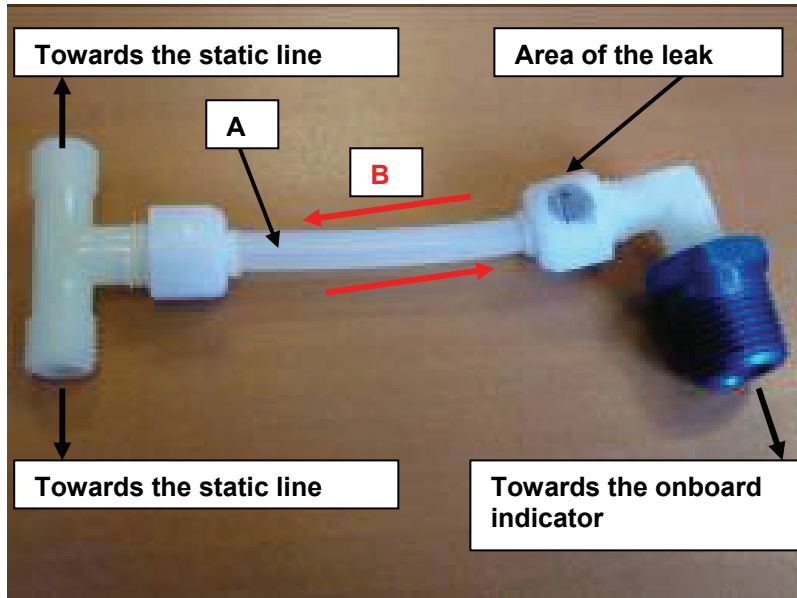
It was possible to establish, during these tests, that the deformation observed on the connector made a perfectly impermeable joint impossible between the pipe and the cabin differential pressure indicator. Due to this, the tube (see "A" figure 8) could be moved in the longitudinal direction though it is, normally, immobilised by the tightening. Without manipulating this tube, no notable leak occurred. As soon as it was displaced in a longitudinal direction (see "B" figure 8), a leak appeared.

Thus, during the impermeability tests performed by Pilatus, on the airplane on the ground, no leak was detected. During departure of the PC 12, the vibrations in flight, as well as the stresses created by the climb with pressurisation of the cabin, very likely led the tube to move, thus causing the leak at the level of the connector.

Figure 8: Photo of the pipes
